OBSERVATION OF THE INITIATION AND PROGRESSION OF  
DAMAGE IN COMPRESSIVELY LOADED COMPOSITE PLATES  
CONTAINING A CUTOUT

**Progress report**

**Grant: NSG 1483**

**November 1986**

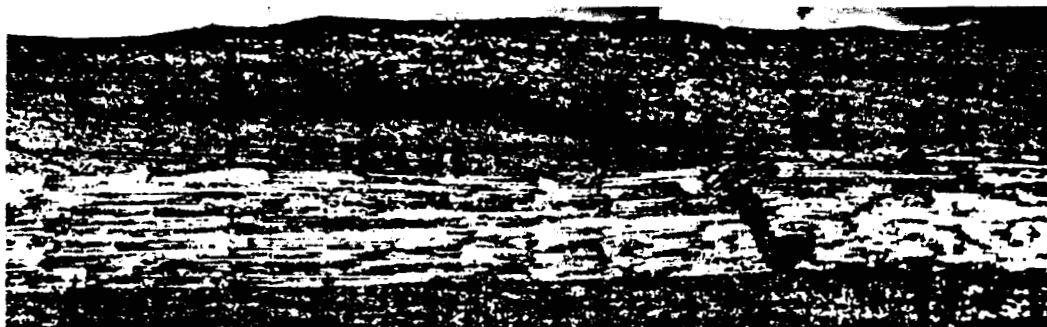
Figure 33. Sectional study indicating surface delamination (spec. TB I7)

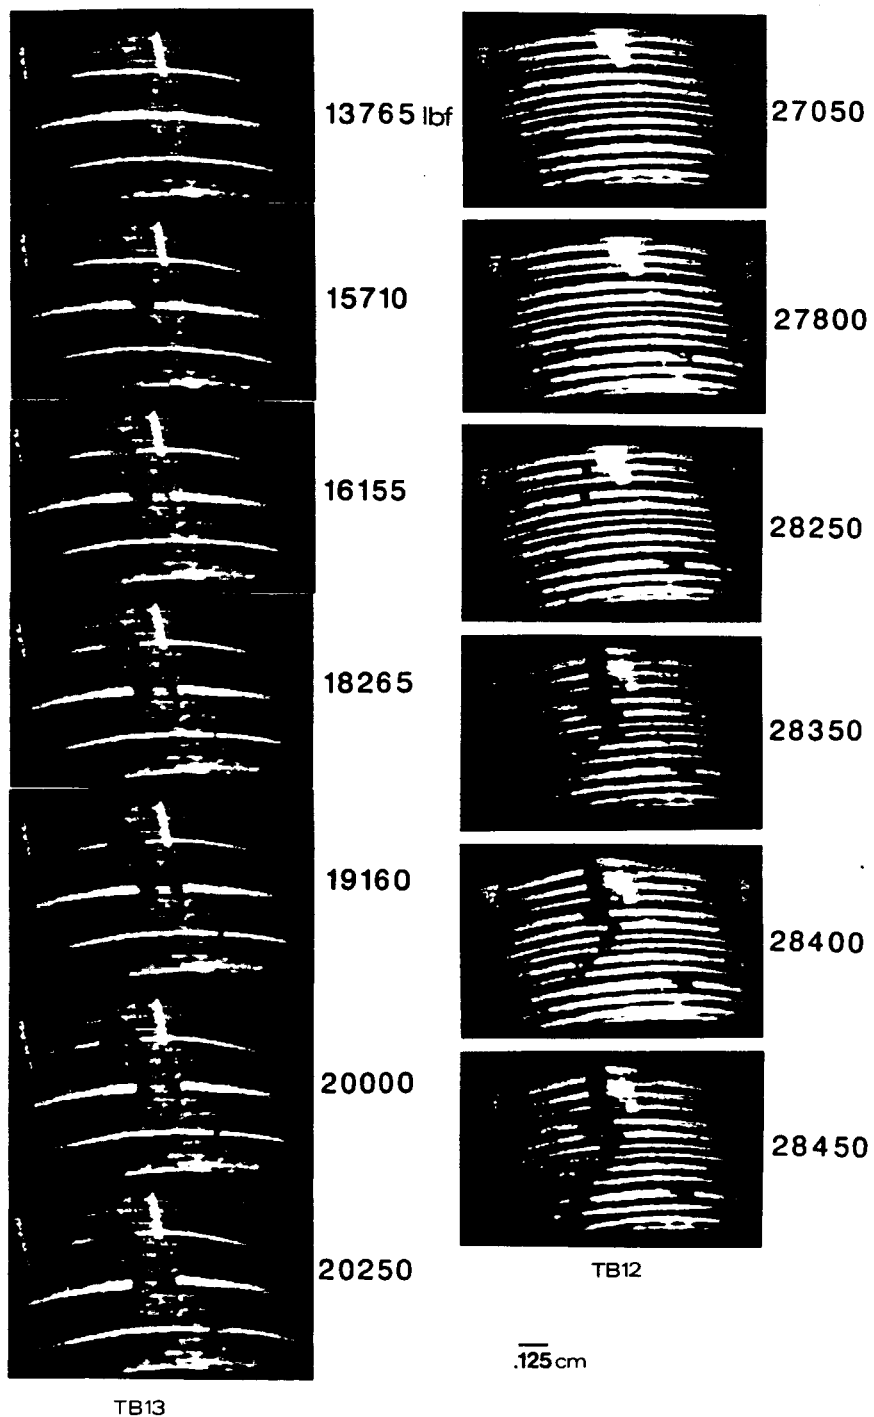
Figure 34. Sequential photomicrographs of hole surface exhibiting damage development.

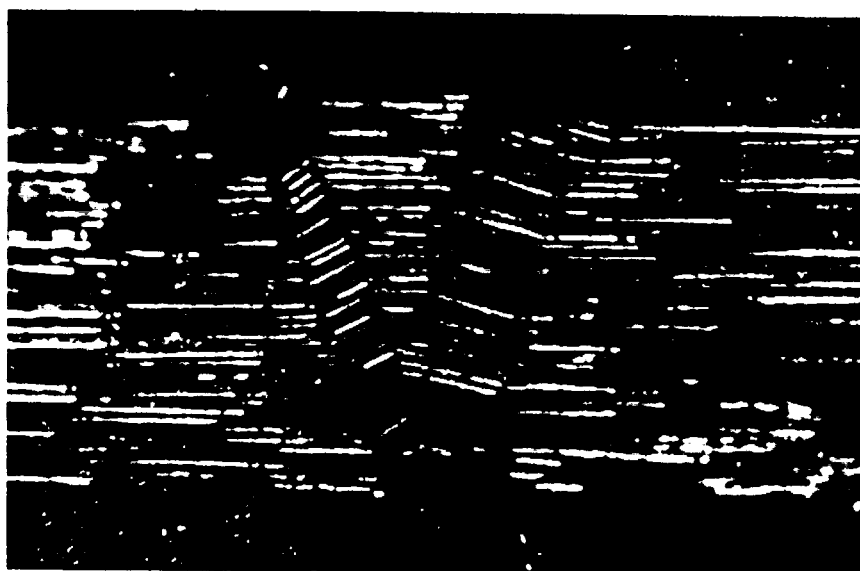
Damage patterns typical of those observed so far are shown in Figure 35. A 3-D view of the damage to a  $0^0$  ply is summarised in Figure 36. This  $0^0$  ply microbuckling/kinking which occurs both, in plane ( $XY$ ) as well as out of plane ( $XZ$ ), is found to persist well into the interior of the specimen. It is conceivable then, that this type of failure originates at the edge of the hole and propagates into the interior of the specimen, causing a narrow zone within the  $0^0$  plies to lose structural integrity. Continuous viewing of the recorded videotapes, shows the surface manifestation of this event as a well defined cluster of fringes originating at the hole edge and propagating rapidly away from the hole. The origination of fiber kinking at a free edge and its subsequent propagation into the interior of the structure has been reported before. We cite here the work of Chaplin [9] and Hahn et al [11].

Figure 35. Forms of internal damage.

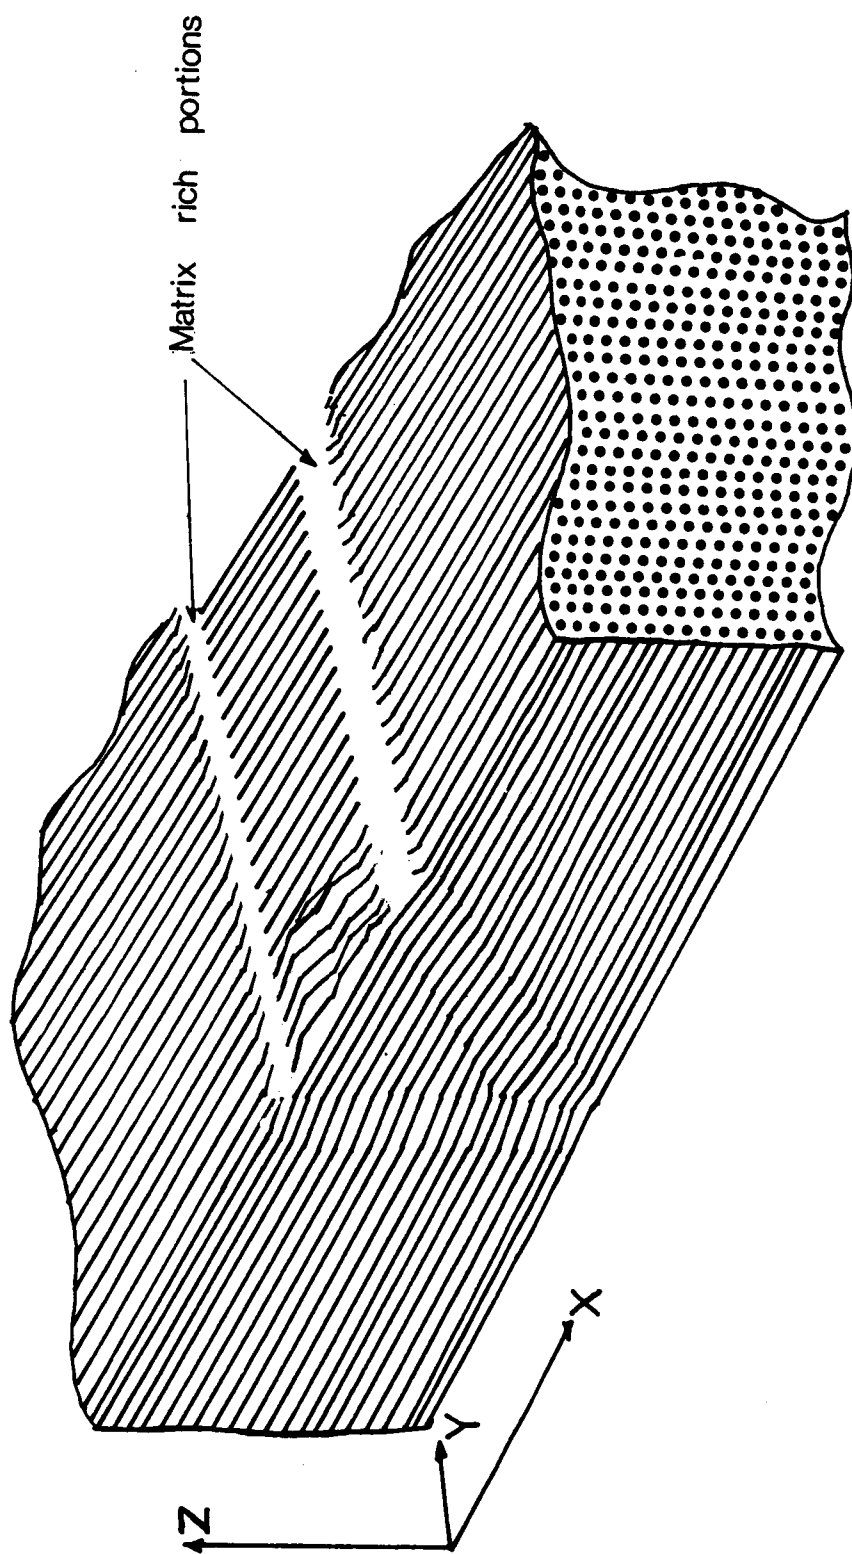
Figure 36. A 3D view of the damage to a zero ply
